MRT – ManuFlo Warranties void if opened by external service personnel / contractors.

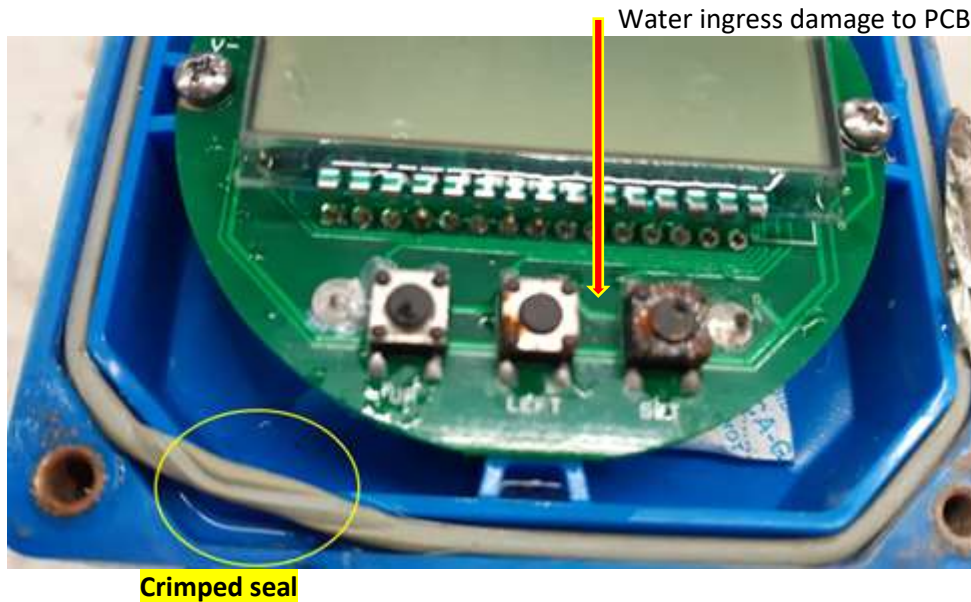
We would like to point out that if warranty sticker seals are broken/removed and thus at some stage the top cover has been opened (possibly by service/calibration people) and when it was replaced the O-ring seal has not been seated in its slot resulting in it becoming crimped as the top cover section was pushed down and thus allowing a cavity for water to ingress resulting in destroying the PCB (see pic below and yellow circle). This is why we place the sealing stickers on the enclosure to discourage from opening. We strongly recommend calibrations be carried out by the use of the **NFC programming** software (available free on our website and utilised with an ANDROID phone with NFC capability -or purchase one from ManuFlo with preloaded software) negating the requirement to open the enclosure. But in the event that the cover is opened it is imperative that the O ring is pushed into the groove and secured before fastening the screws to close the unit up again.

This being the case, return to ManuFlo for replacement of PCB and seal... or order spare parts from ManuFlo for do it yourself replacement.
