Some MRP20-P PULSE OUTPUT M12 heads that appear to be continually damaged in site applications are being returned within the 12 month warranty period.

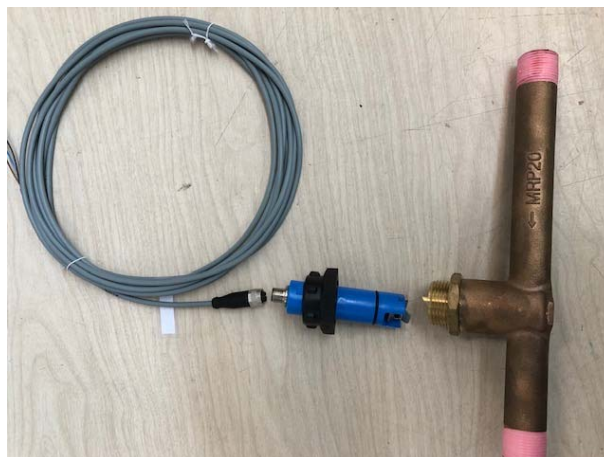
RPFS-P Rota Pulse insertion paddlewheel flowmeter

Totally independent durable blind pulse flowmeter mounted away from the operators and much less prone to damage.

Approx. 100 pulses per litre output

5-25vdc voltage range / pulse switching Inserted into

B20-T2 20mm (3/4") bsp-m gunmetal flowtube adaptor

3/ Consider our tried proven and alternative option below;

Over 1000 units installed on HOLCIM trucks and still working 5 years later without failure.
